**Flood Control Project Maintenance
Levee Inspections**

Fall 2011 Levee Maintenance Deficiency Summary Report

San Joaquin River Basin

Reclamation District No. 2089 Stark

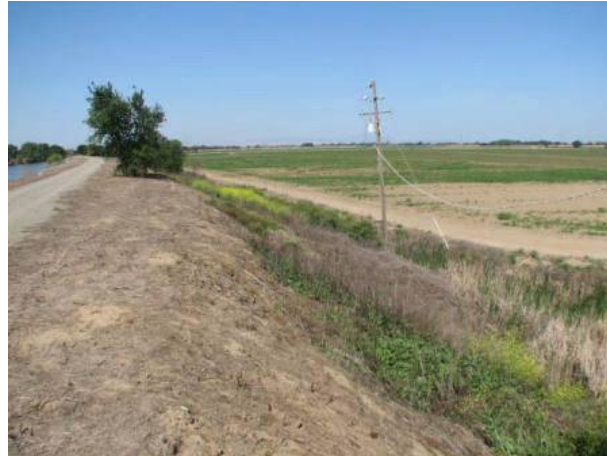
Levee Mile Report Line	2
Start Levee Mile	0.03
End Levee Mile	0.27
Location	Land Side
Category	Earthen Levee
Item	Vegetation
11/10/2011 Landside vegetation obstructs visibility of the slope and toe.	
jeto_f_20111121_599.jpg

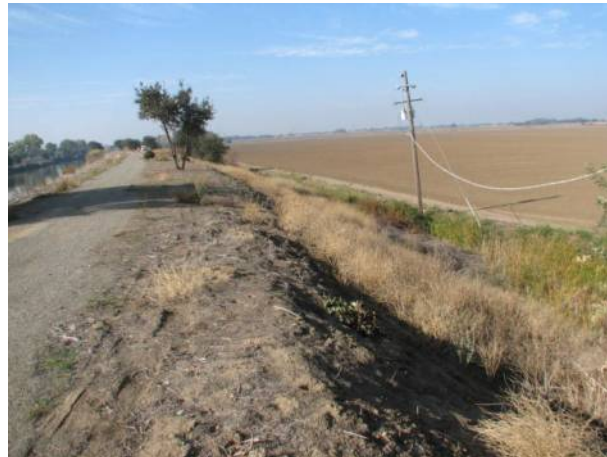
Levee Mile Report Line	3
Start Levee Mile	0.04
End Levee Mile	0.04
Location	Land Side
Category	Earthen Levee
Item	Trim / Thin Trees
Trees on landside slope limit access and visibility.	
jeto_f_20110923_227.jpg

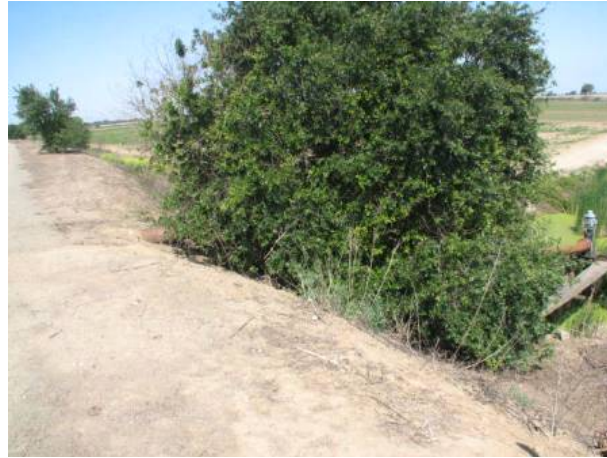
Levee Mile Report Line	4
Start Levee Mile	0.04
End Levee Mile	0.04
Location	Land Side
Category	Earthen Levee
Item	Encroachments
Waterside of drainage discharge to Old River.	
jeto_f_20110923_234.jpg

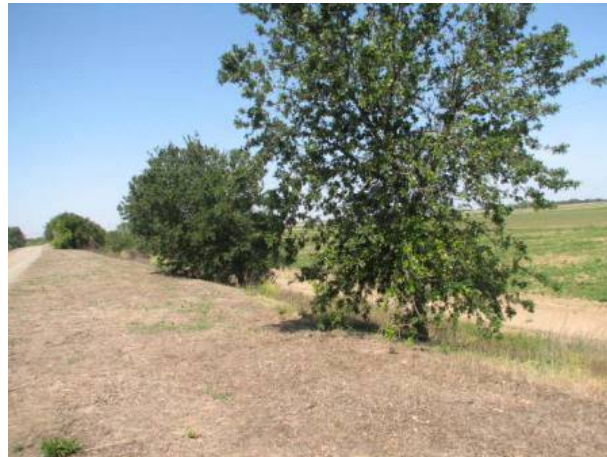
9	0.23	0.23	Earthen Levee	Trim / Thin Trees	LS	M	Trim trees to at least five feet above ground level. Inspector Comments: 05/24/2011 Issue is unchanged since Fall 2010. 11/10/2011 Trees have been limbed up, but needs to be limbed up further to provide full access and visibility.	37.810532 ° -121.388823 °	37.810532 ° -121.388823 °	938 Y

Levee Mile Report Line	9
Start Levee Mile	0.23
End Levee Mile	0.23
Location	Land Side
Category	Earthen Levee
Item	Trim / Thin Trees
05/24/2011 Tree was also noted in the Fall 20110 inspection.	
jeto_f_20110923_259.jpg

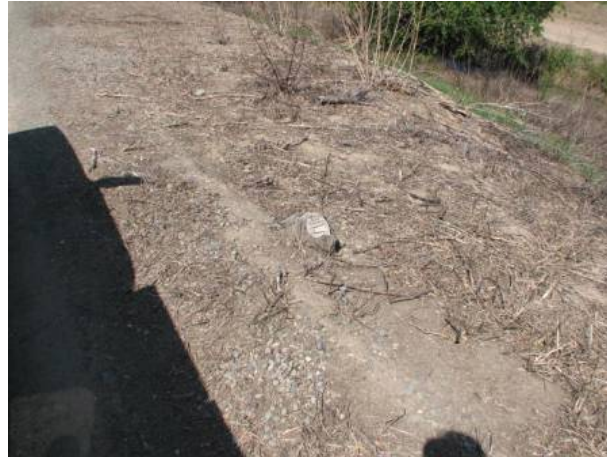
Levee Mile Report Line	15
Start Levee Mile	0.26
End Levee Mile	0.26
Location	Land Side
Category	Earthen Levee
Item	Trim / Thin Trees
11/10/2011 Tree obstructs visibility and access to slope, needs to be limbed up to 5'.	
jeto_f_20111121_602.jpg

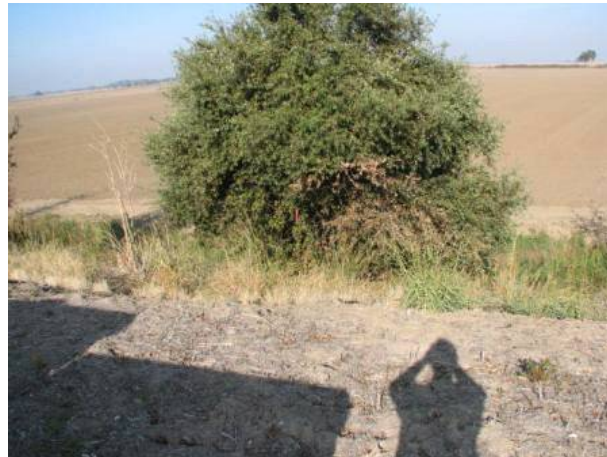
Levee Mile Report Line	16
Start Levee Mile	0.27
End Levee Mile	0.39
Location	Land Side
Category	Earthen Levee
Item	Vegetation
05/24/2011 Thick brush and wild rose completely block access and visibility of landside slope and toe.	
jeto_f_20110923_238.jpg

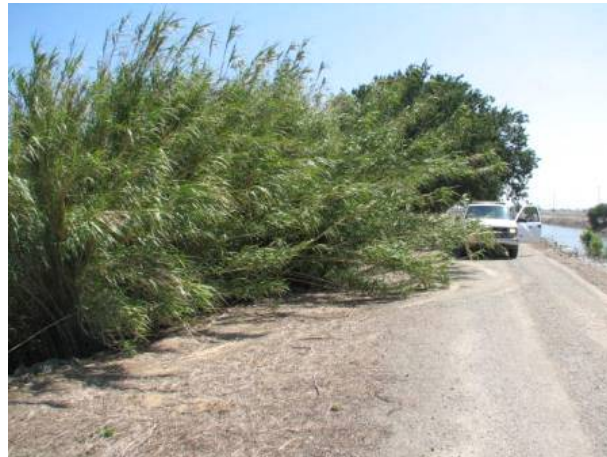
19	0.34	0.34	Earthen Levee	Vegetation	LS	U	Remove the wild growth other than native grasses from the levee slopes. Inspector Comments: Bamboo completely blocks access and visibility.11/10/2011 Arundo has been trimmed back from the roadway, but still completely blocks access and visibility to the landside slope. This plant was improperly identified as bamboo in previous inspections.	37.809978 ° -121.390704 °	37.809978 ° -121.390704 °	19 Y
20	0.38	0.38	Earthen Levee	Trim / Thin Trees	LS	U	Trim trees to at least five feet above ground level.	37.809865 ° -121.391303 °	37.809865 ° -121.391303 °	946 Y
21	0.39	0.39	Earthen Levee	Trim / Thin Trees	LS	M	Thin trees to allow visibility of the ground and room to flood fight.	37.809788 ° -121.391490 °	37.809788 ° -121.391490 °	26 Y
22	0.41	0.41	Supplemental	DWR Erosion Survey	WS	W	Inspector Comments: 08/23/2011: Boat survey uncovered a 10-ft vertical scarp just upstream of the revetment. Vegetation and trees on site. 09/07/2010: Site appears to have been repaired by placing shot rock as rip rap protection. Note patches of seasonal grass on revetment. It is recommended that an inspection in the near future be conducted to verify the condition of the revetment. Site was previously rated "M".08/06/2010: Recommended as local maintenance issue, per CLRO.09/28/2009: Rock protection was recently placed along the upper slope; photographs need to be updated; site is recommended for annual assessment and monitoring of erosion site, per CLRO CES Evaluation 2008 Report; Site # is the same as RM29.84,LM0.30; previously rated "M".11/05/2008: Two sites have been combined as one supersite; steep ws slope and downstream of a pump.10/20/2006: Visited site 10/20/2006. [2011 Site ID:RD2089U01RM29.83]	37.809530 ° -121.392160 °	37.809530 ° -121.392160 °	52 Y

Levee Mile Report Line	19
Start Levee Mile	0.34
End Levee Mile	0.34
Location	Land Side
Category	Earthen Levee
Item	Vegetation
11/10/2011 Arundo has been trimmed back from the road, but needs to be removed to so that it does not obstruct visibility and access to the landside slope.	
jeto_f_20111121_603.jpg

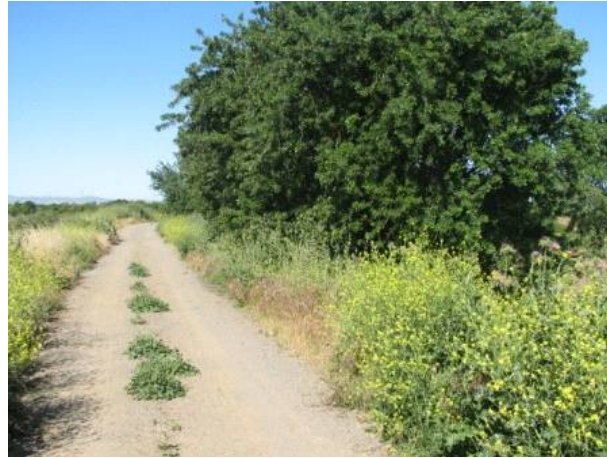
Levee Mile Report Line	21
Start Levee Mile	0.39
End Levee Mile	0.39
Location	Land Side
Category	Earthen Levee
Item	Trim / Thin Trees
05/24/2011 Tree needs to be trimmed up 5' to allow access and visibility to landside slope.	
jeto_f_20110923_246.jpg

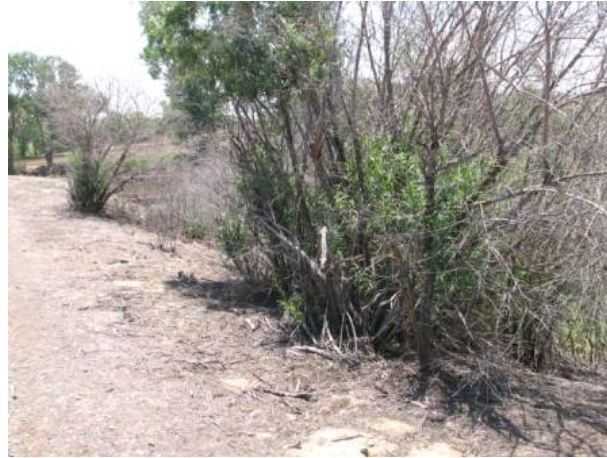
Levee Mile Report Line	27
Start Levee Mile	0.50
End Levee Mile	0.50
Location	Water Side
Category	Earthen Levee
Item	Trim / Thin Trees
11/10/2011 Woody vegetation needs to be cleared off of the upper 20' of the waterside slope.	
jeto_f_20111121_604.jpg

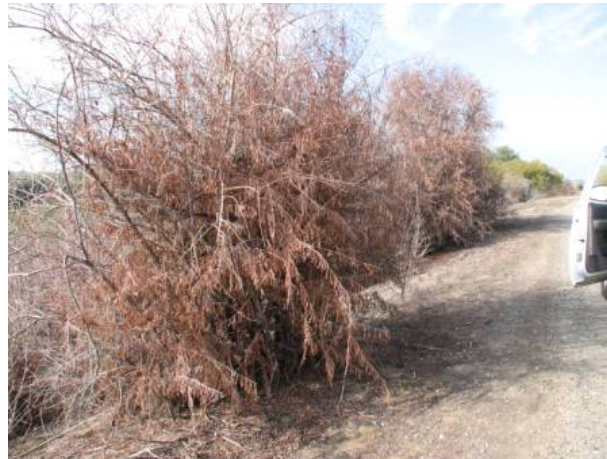
Levee Mile Report Line	28
Start Levee Mile	0.50
End Levee Mile	0.50
Location	Land Side
Category	Earthen Levee
Item	Vegetation
05/24/2011 Dead brush is too thick to allow access and visibility of landside slope and toe.	
jeto_f_20110923_250.jpg

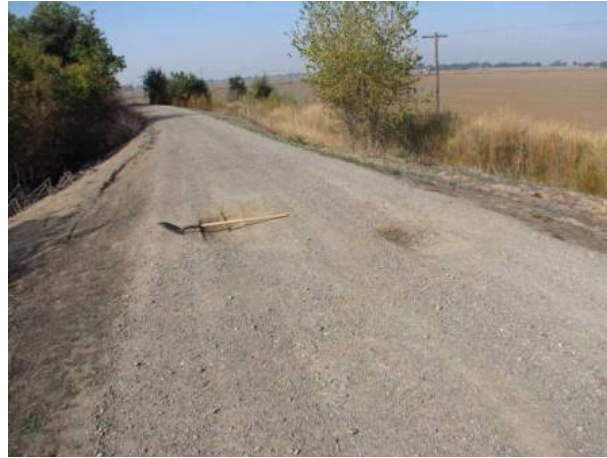
30	0.60	0.60	Earthen Levee	Trim / Thin Trees	LS	M	Trim trees to at least five feet above ground level. Inspector Comments: 05/24/2011 Issue remains unchanged since Fall 2010, photo attached	37.810230 ° -121.394967 °	37.810230 ° -121.394967 °	950 Y
31	0.64	1.53	Earthen Levee	Vegetation	WS	U	Remove the wild growth other than native grasses from the levee slopes. Inspector Comments: 11/10/2011 Waterside vegetation is too thick to allow access and visibility.	37.810048 ° -121.395762 °	37.806534 ° -121.407531 °	18 Y
32	0.64	0.64	Earthen Levee	Trim / Thin Trees	LS	M	Trim trees to at least five feet above ground level.	37.810130 ° -121.395732 °	37.810130 ° -121.395732 °	951 Y

Levee Mile Report Line	30
Start Levee Mile	0.60
End Levee Mile	0.60
Location	Land Side
Category	Earthen Levee
Item	Trim / Thin Trees
05/24/2011 Issue was also noted in Fall 2010 inspection.	
jeto_f_20110923_264.jpg

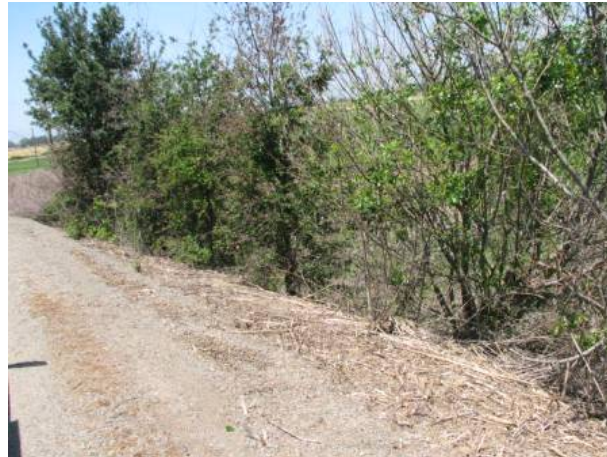
Levee Mile Report Line	31
Start Levee Mile	0.64
End Levee Mile	1.53
Location	Water Side
Category	Earthen Levee
Item	Vegetation
11/10/2011 Vegetation needs to be cleared on the upper 20' of the waterside slope.	
jeto_f_20111121_607.jpg

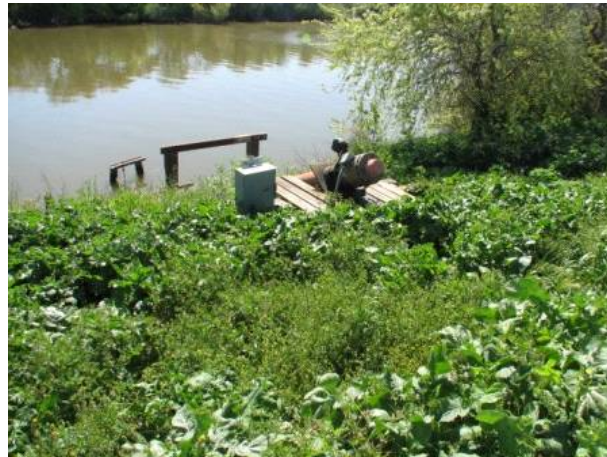
Levee Mile Report Line	39
Start Levee Mile	0.85
End Levee Mile	0.85
Location	Land Side
Category	Earthen Levee
Item	Encroachments
05/24/2011 Photo shows tilling issue noted in Fall 2010 inspection has been corrected, tilling now stops at toe of landside slope.	
jeto_f_20110923_253.jpg

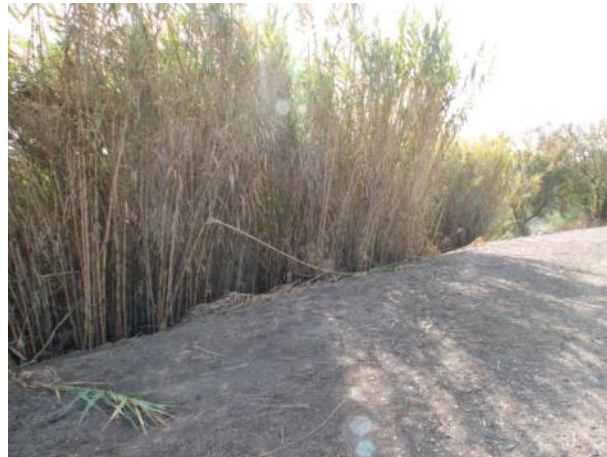
Levee Mile Report Line	42
Start Levee Mile	0.97
End Levee Mile	0.97
Location	Land Side
Category	Earthen Levee
Item	Trim / Thin Trees
05/24/2011 Tree needs to be trimmed up 5'.	
jeto_f_20110923_254.jpg

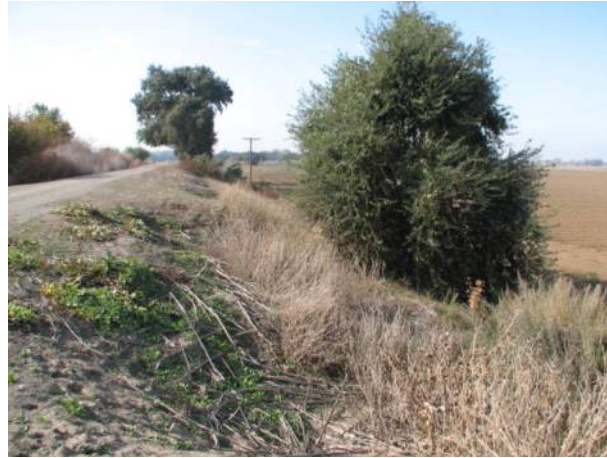
Levee Mile Report Line	44
Start Levee Mile	0.98
End Levee Mile	1.07
Location	Water Side
Category	Earthen Levee
Item	Vegetation
11/10/2011 Thick vegetation on upper 20; of waterside slope.	
jeto_f_20111121_612.jpg

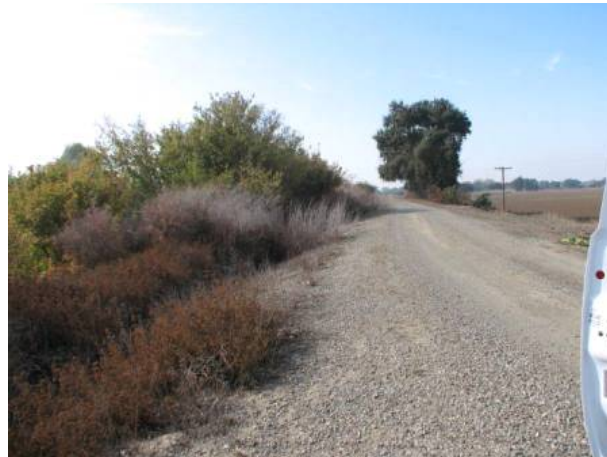
Levee Mile Report Line	50
Start Levee Mile	1.16
End Levee Mile	1.16
Location	Land Side
Category	Earthen Levee
Item	Encroachments
11/10/2011 Section of ductilie iron pipe that speears to be left from a pipe repair. Needs to be removed.	
jeto_f_20111121_613.jpg

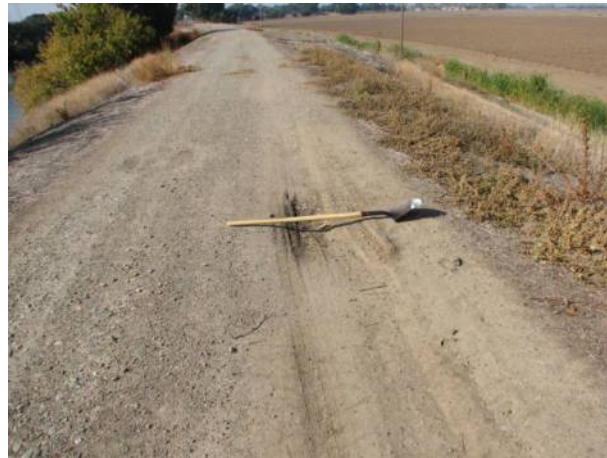
Levee Mile Report Line	57
Start Levee Mile	1.38
End Levee Mile	1.38
Location	Crown
Category	Earthen Levee
Item	Crown Surface / Depressions / Rutting
11/10/2011 Roadway depression.	
jeto_f_20111121_616.jpg

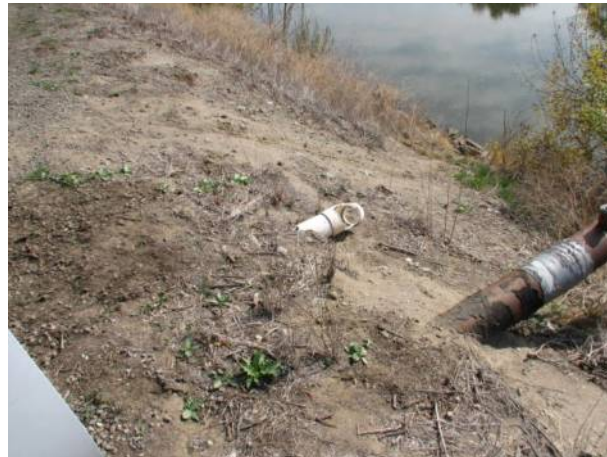
Levee Mile Report Line	60
Start Levee Mile	1.45
End Levee Mile	1.45
Location	Crown
Category	Earthen Levee
Item	Encroachments
11/10/2011 PVC pipe on landside slope. Pipe needs to be removed.	
jeto_f_20111121_620.jpg

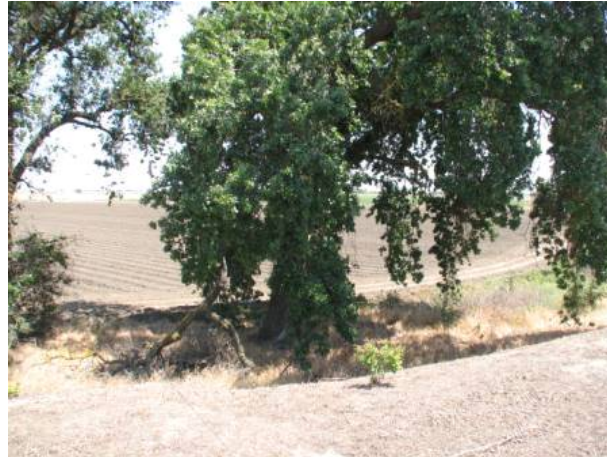
Levee Mile Report Line	3
Start Levee Mile	0.08
End Levee Mile	0.08
Location	Water Side
Category	Earthen Levee
Item	Vegetation
Fall 2009 photo of unacceptable vegetation on levee slope.	
jeto_f_20110923_270.jpg

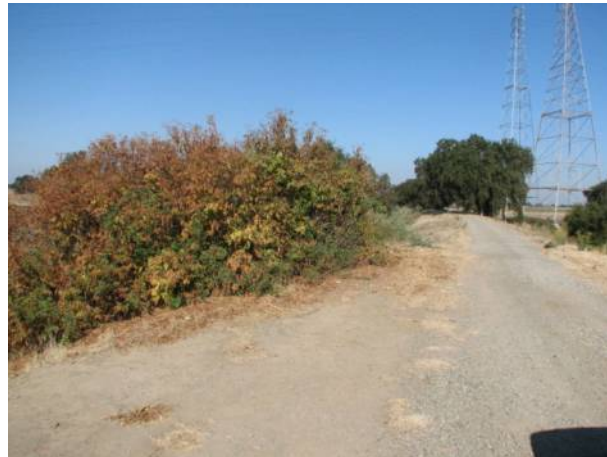
Levee Mile Report Line	3
Start Levee Mile	0.08
End Levee Mile	0.08
Location	Water Side
Category	Earthen Levee
Item	Vegetation
05/24/2011 Updated photo of issue noted in Fall 2010 inspection.	
jeto_f_20110923_271.jpg

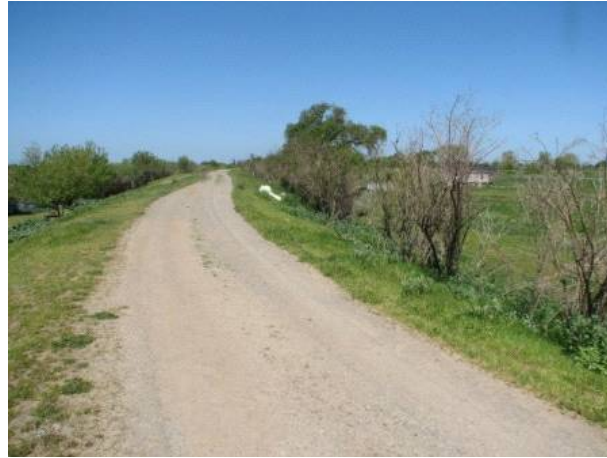
LMR No.	Levee Mile		Category	Item	Location	Rating	Action/Comment	GPS Latitude/Longitude		Issue No.
	Start	End						Start	End	
11	0.42	0.43	Supplemental	DWR Erosion Survey	WS	U	Inspector Comments: 08/23/2011: No significant changes observed on site. 09/07/2010: Site consists of a jutting rip rap that has created an eddy, scouring the levee slope. Most sections of the toe and lower slope are lined with rip rap. However, the rip rap is sloughing on the mid slope and at the toe, exposing the underlying soils and tree roots. The remaining revetment is no longer adequately protecting the slope. There are 3 Sycamore trees at the toe with exposed tree roots. 08/05/2010: Recommended for repair, per CLRO.09/28/2009: Pocket erosion on lower slope just above the toe rip rap; protruding rip rap upstream is creating an eddy, scouring the levee slope; Site # is the same as RM28.40, LM0.30; previously rated "U"; pictures will be made available during the next survey. 11/05/2008: Cut into levee profile; riprap slide; rodent holes; pictures do not match GPS and current condition. [2011 Site ID: RD2089U02RM28.35]	37.809960 ° -121.413200 °	37.809960 ° -121.413200 °	1 Y

Levee Mile Report Line	11
Start Levee Mile	0.42
End Levee Mile	0.43
Location	Water Side
Category	Supplemental
Item	DWR Erosion Survey
Upstream view of the site where minor erosion activities observed.	
SJR2011_RD2089U02RM28.35_1.jpg

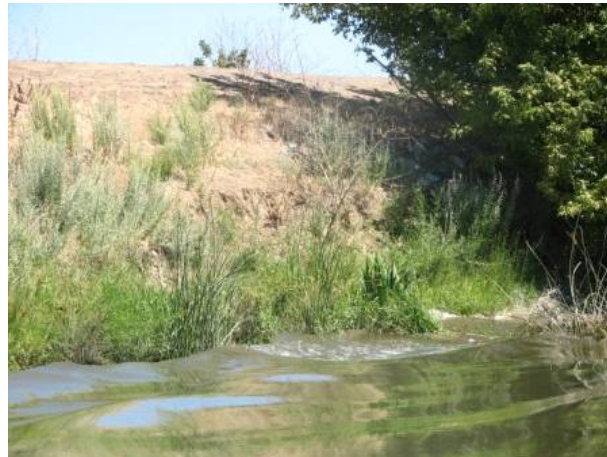
Levee Mile Report Line	11
Start Levee Mile	0.42
End Levee Mile	0.43
Location	Water Side
Category	Supplemental
Item	DWR Erosion Survey
A closer look of the site with minor erosions.	
SJR2011_RD2089U02RM28.35_2.jpg

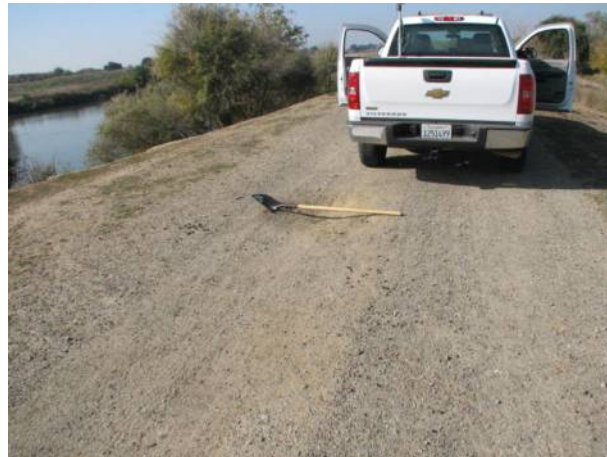
Levee Mile Report Line	15
Start Levee Mile	0.54
End Levee Mile	0.54
Location	Water Side
Category	Earthen Levee
Item	Animal Control
11/10/2011 Approximately 1' scarp has been created by livestock travel.	
jeto_f_20111118_598.jpg

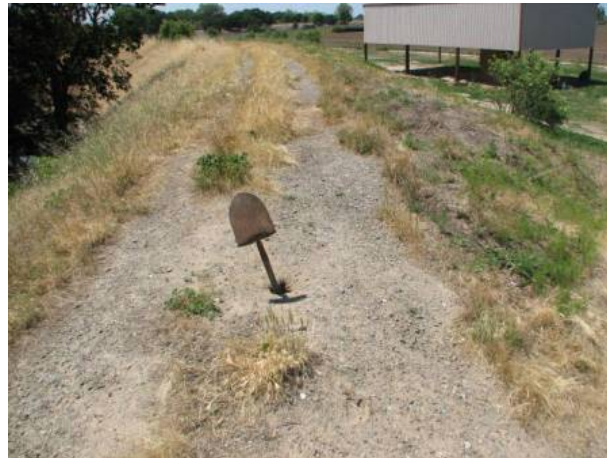
Levee Mile Report Line	25
Start Levee Mile	0.87
End Levee Mile	0.92
Location	Land Side
Category	Earthen Levee
Item	Animal Control
05/24/2011 Deep vertical burrow in ramp on land side of levee.	
jeto_f_20110923_290.jpg
